test report

Supplier：	Zhejiang	Po No.：	20KD88182001
CUST No.:	NIK18071	Inspection unit：	验货房
Factory Contact ：	20KD88182001	Inspection Date ：	11/18/20

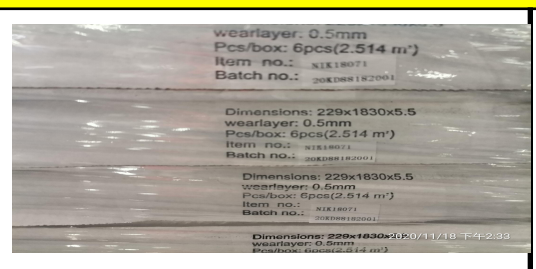
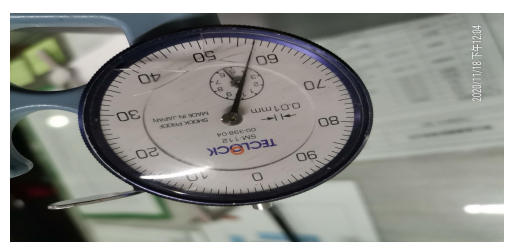
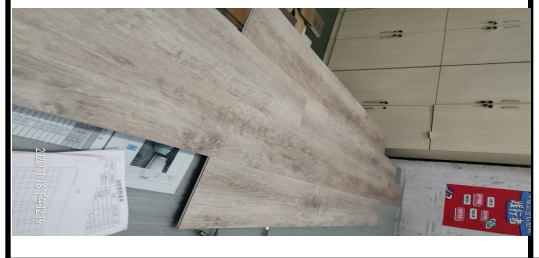
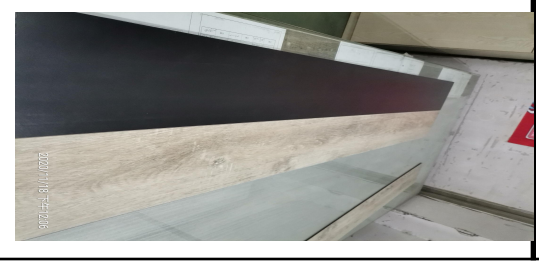
验货照片

inspection item	TCF	Measured Data			Result
Length	Length：+0.3mm/-0mm	1830,02	1830,06	1830,08	√
Width	Width：+0.12mm/-0mm	229,01	229,05	229,08	√
Thickness	+0.2mm-0.15mm	5,57	5,56	5,57	√
Gloss	±1.5°	5,5	5,6	5,1	√
Shrinkage rate	ESPC≤0.08%	0,04%			√
expansion rate	≤0.15%	0,09%			√
Curling after exposure to heat:	ESPC≤1mm	0,60			√
opengings	≤0.1mm	0,10			√
Height difference	≤0.15mm	0,10			√
Batch No.、Click type	Accoring to the order requirments	OK			√
Label	1.The label is not re-attached, floating, or skewed. 2. the Lable is same as the order requirments	OK			√
Carton	1.The carton shall not be damaged ,worn ,dirty or fade 2.The carton should be put in order. 3.Confirm if the carton is same as the order requirments	OK			√
Pallet	The pallet surface shoule be smooth and flat,pallet blocks shall not be damaged,pallet size should be same to the order	OK			√
Appearance	Inspection Level：AQL LevelII 2.5&4.0	Impurity material inside the surface：1pc			√

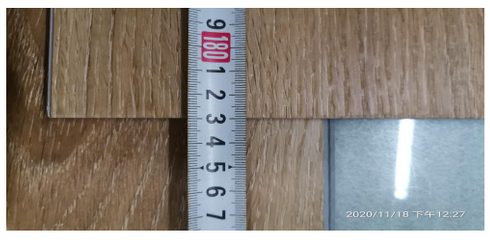
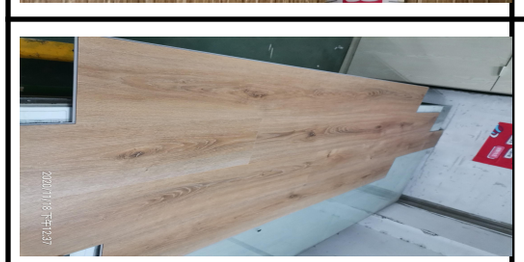
验货照片

inspection item	TCF	Measured Data			Result
Length	Length：+0.3mm/-0mm	1830,02	1830,06	1830,08	√
Width	Width：+0.12mm/-0mm	229,02	229,06	229,05	√
Thickness	+0.2mm-0.15mm	5,55	5,60	5,58	√
Gloss	±1.5°	5,6	5,4	5,4	√
Shrinkage rate	ESPC≤0.08%	0,04%			√
expansion rate	≤0.15%	0,11%			√
Curling after exposure to heat:	ESPC≤1mm	0,60			√
opengings	≤0.1mm	0,10			√
Height difference	≤0.15mm	0,10			√
Batch No.、Click type	Accoring to the order requirments	OK			√
Label	1.The label is not re-attached, floating, or skewed. 2. the Lable is same as the order requirments	OK			√
Carton	1.The carton shall not be damaged ,worn ,dirty or fade 2.The carton should be put in order. 3.Confirm if the carton is same as the order requirments	OK			√
Pallet	The pallet surface shoule be smooth and flat,pallet blocks shall not be damaged,pallet size should be same to the order	OK			√
Appearance	Inspection Level：AQL LevelII 2.5&4.0	Dirty mark on the surface：1pc			√

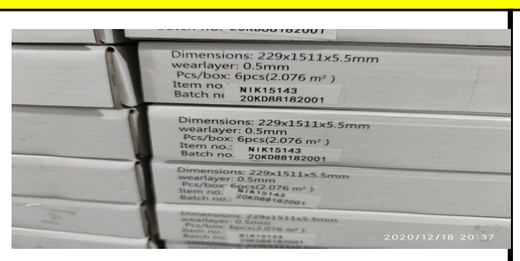
Inspection picture

inspection item	TCF	Measured Data			Result
Length	Length：+0.3mm/-0mm	1511,00	1511,00	1511,00	√
Width	Width：+0.12mm/-0mm	229,00	229,00	229,00	√
Thickness	+0.2mm-0.15mm	5,56	5,59	5,57	√
Gloss	±1.5°	5,4	5,7	6,1	√
Shrinkage rate	ESPC≤0.08%	0,03%			√
expansion rate	≤0.15%	0,08%			√
Curling after exposure to heat:	ESPC≤1mm	0,40			√
opengings	≤0.1mm	0,10			√
Height difference	≤0.15mm	0,10			√
Batch No.、Click type	Accoring to the order requirments	OK			√
Label	1.The label is not re-attached, floating, or skewed. 2. the Lable is same as the order requirments	OK			√
Carton	1.The carton shall not be damaged ,worn ,dirty or fade 2.The carton should be put in order. 3.Confirm if the carton is same as the order requirments	OK			√
Pallet	The pallet surface shoule be smooth and flat,pallet blocks shall not be damaged,pallet size should be same to the order	OK			√
Appearance	Inspection Level：AQL LevelII 2.5&4.0	Impurity material inside the surface： 1pc			√
